TEST REPORT

SCOPE OF WORK NEMA 4X TESTING-- See page 2

REPORT NUMBER 230609070GZU-001

(BLUETTI)
Model No. B500
Rating NEMA 4X
Date Received 09 June 2023
Date Test Conducted Refer to cl.8.6, 8.9 and 8.13 of UL 50E

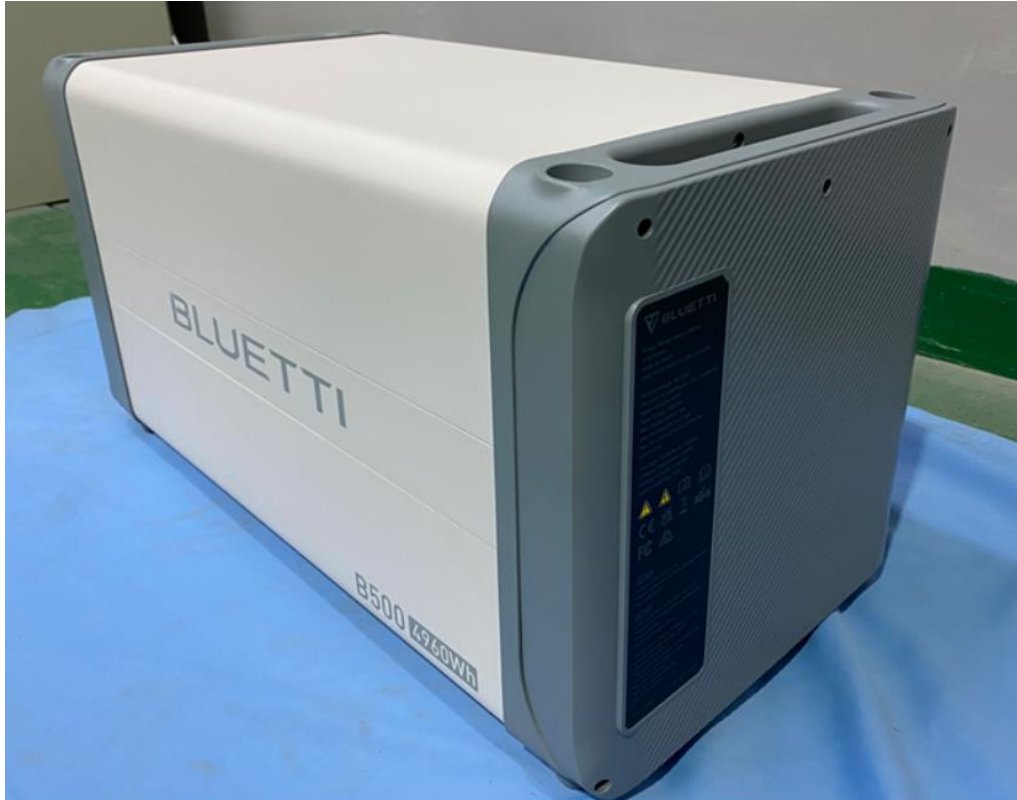
The whole unit before test

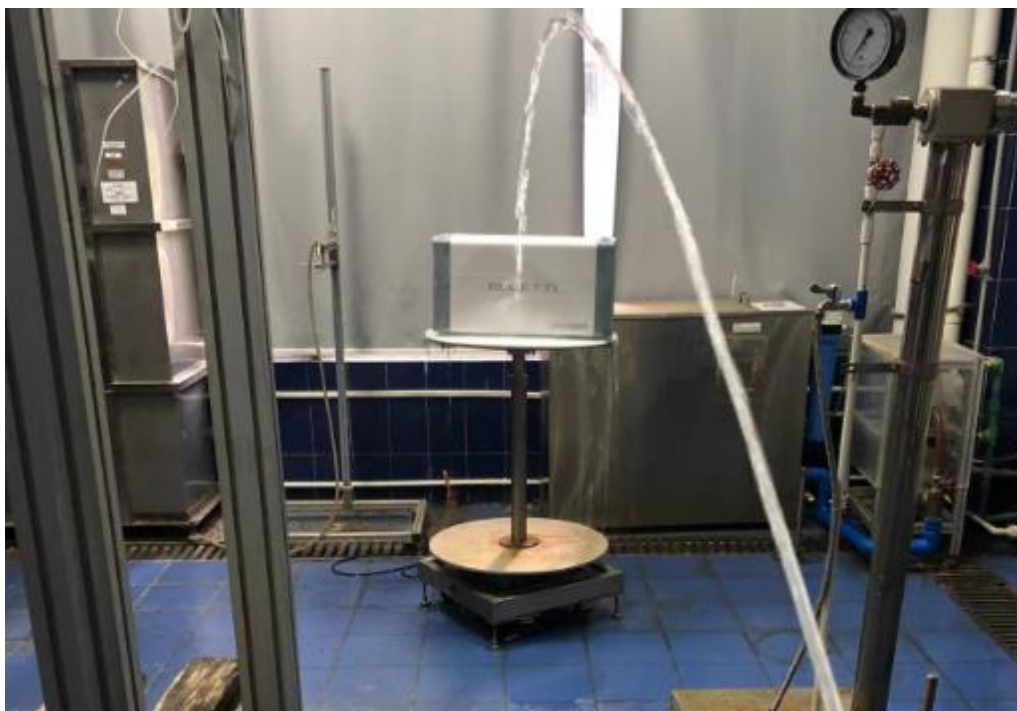
Hosedown test setup

8.6	TABLE: Hosedown		P
Test condition		Test result	
Internal diameter of the nozzle	25mm	No water inside the enclosure	
Delivery rate:	240 L per minute		
Distance from nozzle to enclosure surface	3.0m

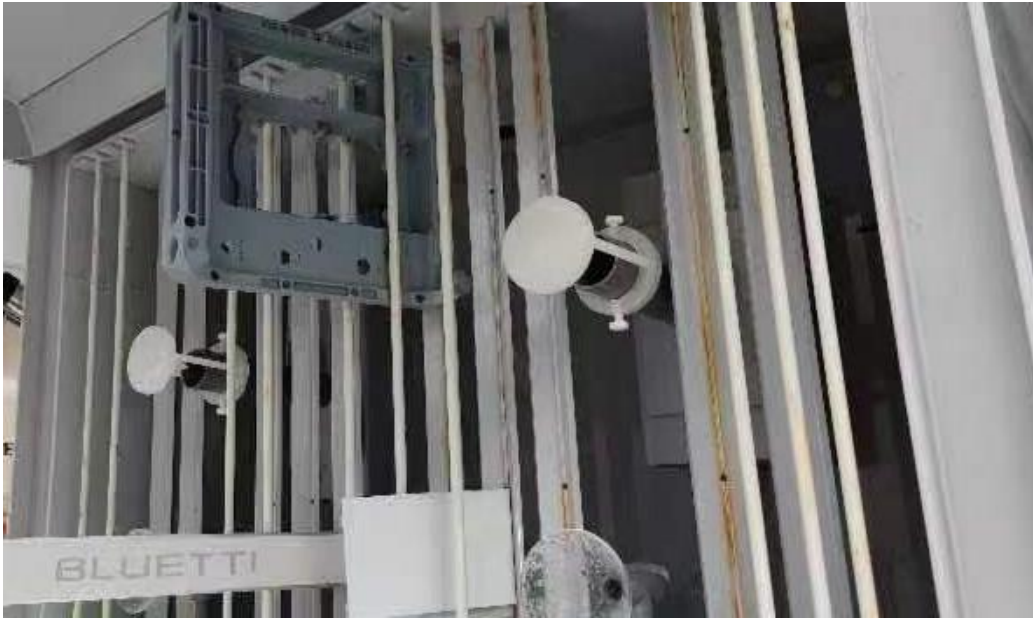
Additional corrosion protection test setup

8.9	TABLE: Additional corrosion protection		P
Test condition		Test result	
Salt used	Analytical reagent	Sample 1 (Center enclosure)	Sample 2 (Side enclosure)
Water used	Conductivity not higher than 20 μ S/cm	After 200 hours neutral salt spray test, the test surface was not corroded.	
Salt concentration of the collected solution	1.031		
PH of collected solution	6.8		
Temperature in test chamber	35°C		
Temperature in the saturation tower	45°C		
Atomizing pressure	70kPa		
Angle at which the tested surfaces were inclined	20°C		
Volume of the collected solution	1.53mL/h		
Intervals of inspection	24h		
Duration of the test	200h

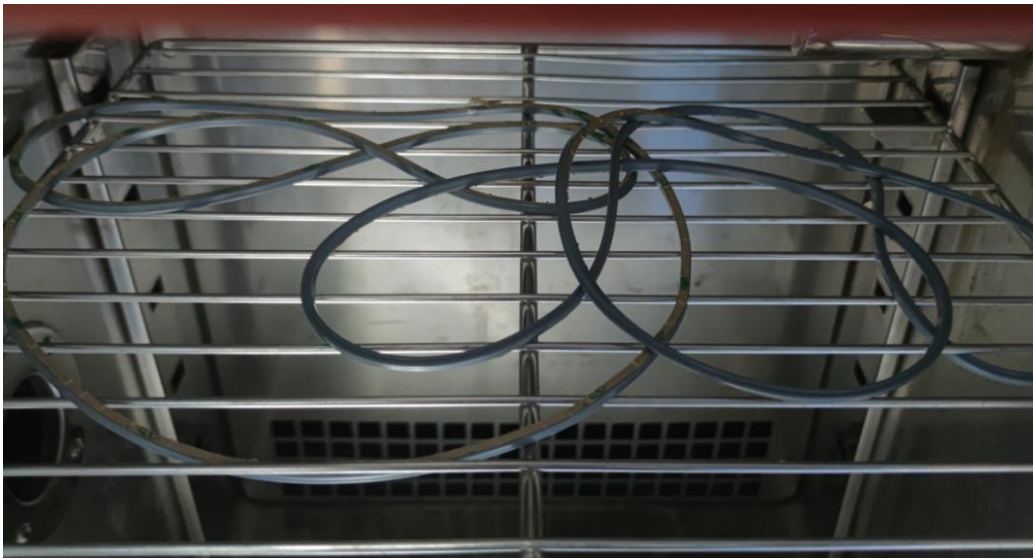
Gasket test setup

Table 8.13	Gasket tests		P
8.13.2 Tensile strength and elongation tests			
	Tensile strength (percent of aged/ unaged)	Elongation (percent of aged/ unaged)	
Test result	92.3%	84.2%	
Limit	≥75%	≥60%	
8.13.3 Compression test			
	Compression percent		
	Sample 1	Sample 2	Sample 3
8.13.3.2 After 69kPa 2h, remove weight and rest at room temperature for 30 min.	1%	1%	1%
8.13.3.3 After 70°C 5 days, and then repeat 8.13.3.2 approximately 24h after removal from the oven	1%	1%	1%
8.13.3.4 After -30°C 24h, impact from a hammer of 1.35 kg mass falling from a height of 150 mm, 3 cycles, and then removed from the cold chamber to rest at room temperature 24h. Repeat 8.13.3.2	1%	1%	1%
Limit	≤50%	≤50%	≤50%
